Images of Plasma Disruption Effects in the Tokamak Fusion Test Reactor (TFTR)

Ricardo J. Maqueda and Glen A. Wurden

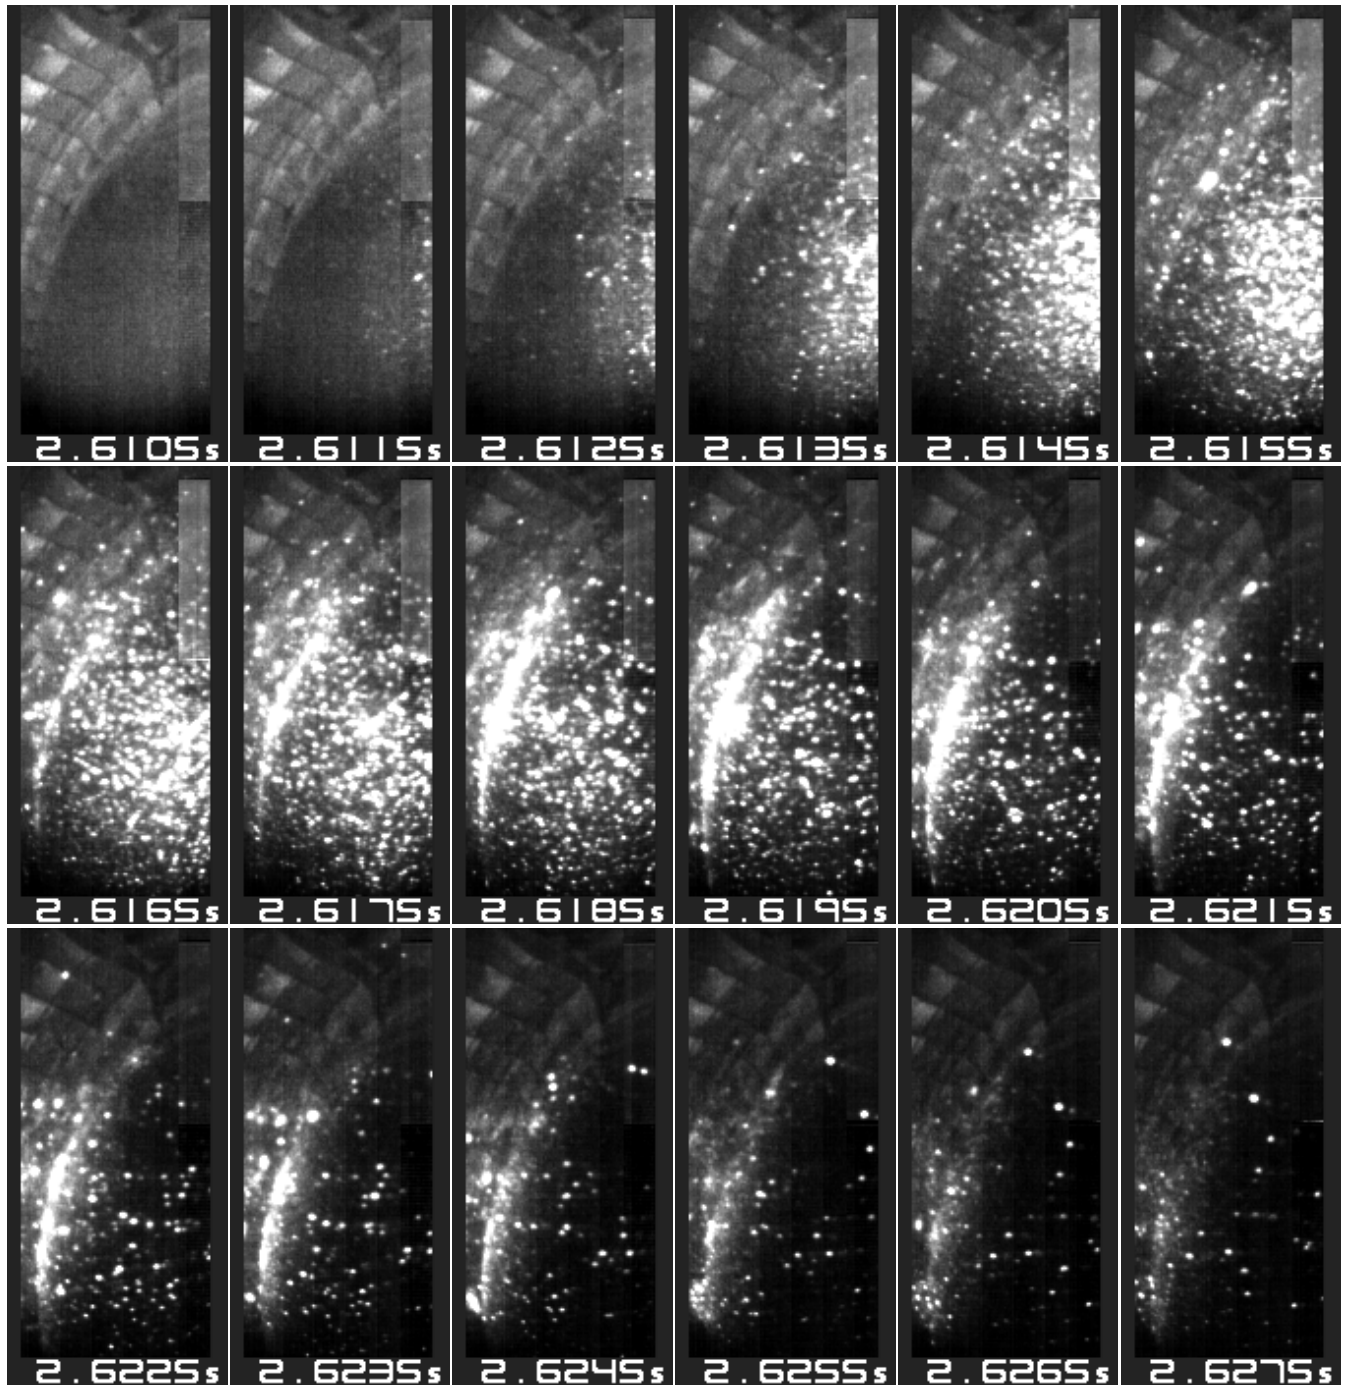
Fig. 1. Horizontal shower of debris “falls” over the inner bumper limiter of TFTR. The images were obtained with $30 \mu\text{s}$ exposure in white visible light (i.e., no interference filter).

Tokamak plasma discharges occasionally end with a disruption: a sudden loss of equilibrium and confinement. Some of these disruptions are caused by MHD perturbations that stop rotating with the plasma column, lock on to the wall (i.e., field error), and grow in amplitude without saturation [5]. In Fig. 1 the effects of a disruption caused by a rotating $m=4$ $n=1$ mode that locks to the vessel wall are shown (discharge 103681). This disruption takes place ~ 2.425 s after discharge initiation. The images in this figure were obtained at a sampling rate of 2 kHz, although every other image (i.e., 1 ms spacing) is shown. As a reference, the tiles on the bumper limiter are nominally 10 cm \times 10 cm in size.

In this example a ~ 0.6 MA toroidal current remains after the disruption. This current is mostly carried by runaway electrons created by the strong electric fields present during the quench of the toroidal (ohmic) plasma current [5]. These high energy (~ 20 MeV) electrons collide into plasma facing components causing damage. In Fig. 1 the damage manifest itself by a (horizontal) shower of debris that “falls” over the bumper limiter above the device midplane. Although not as spectacular as the example shown here, flying debris is almost always seen after disruptions. The diameter of the hot-glowing flying particles is estimated to be up to 1 cm and their speed is of the order of 100 m/s. It is speculated that the debris seen in these images is part of the Faraday shield for the RF heating antenna (IBW) that was located approximately opposite to the section of bumper limiter shown and that was noticed missing a few weeks later.
