# Images of Plasma Disruption Effects in the Tokamak Fusion Test Reactor (TFTR)

Ricardo J. Maqueda and Glen A. Wurden

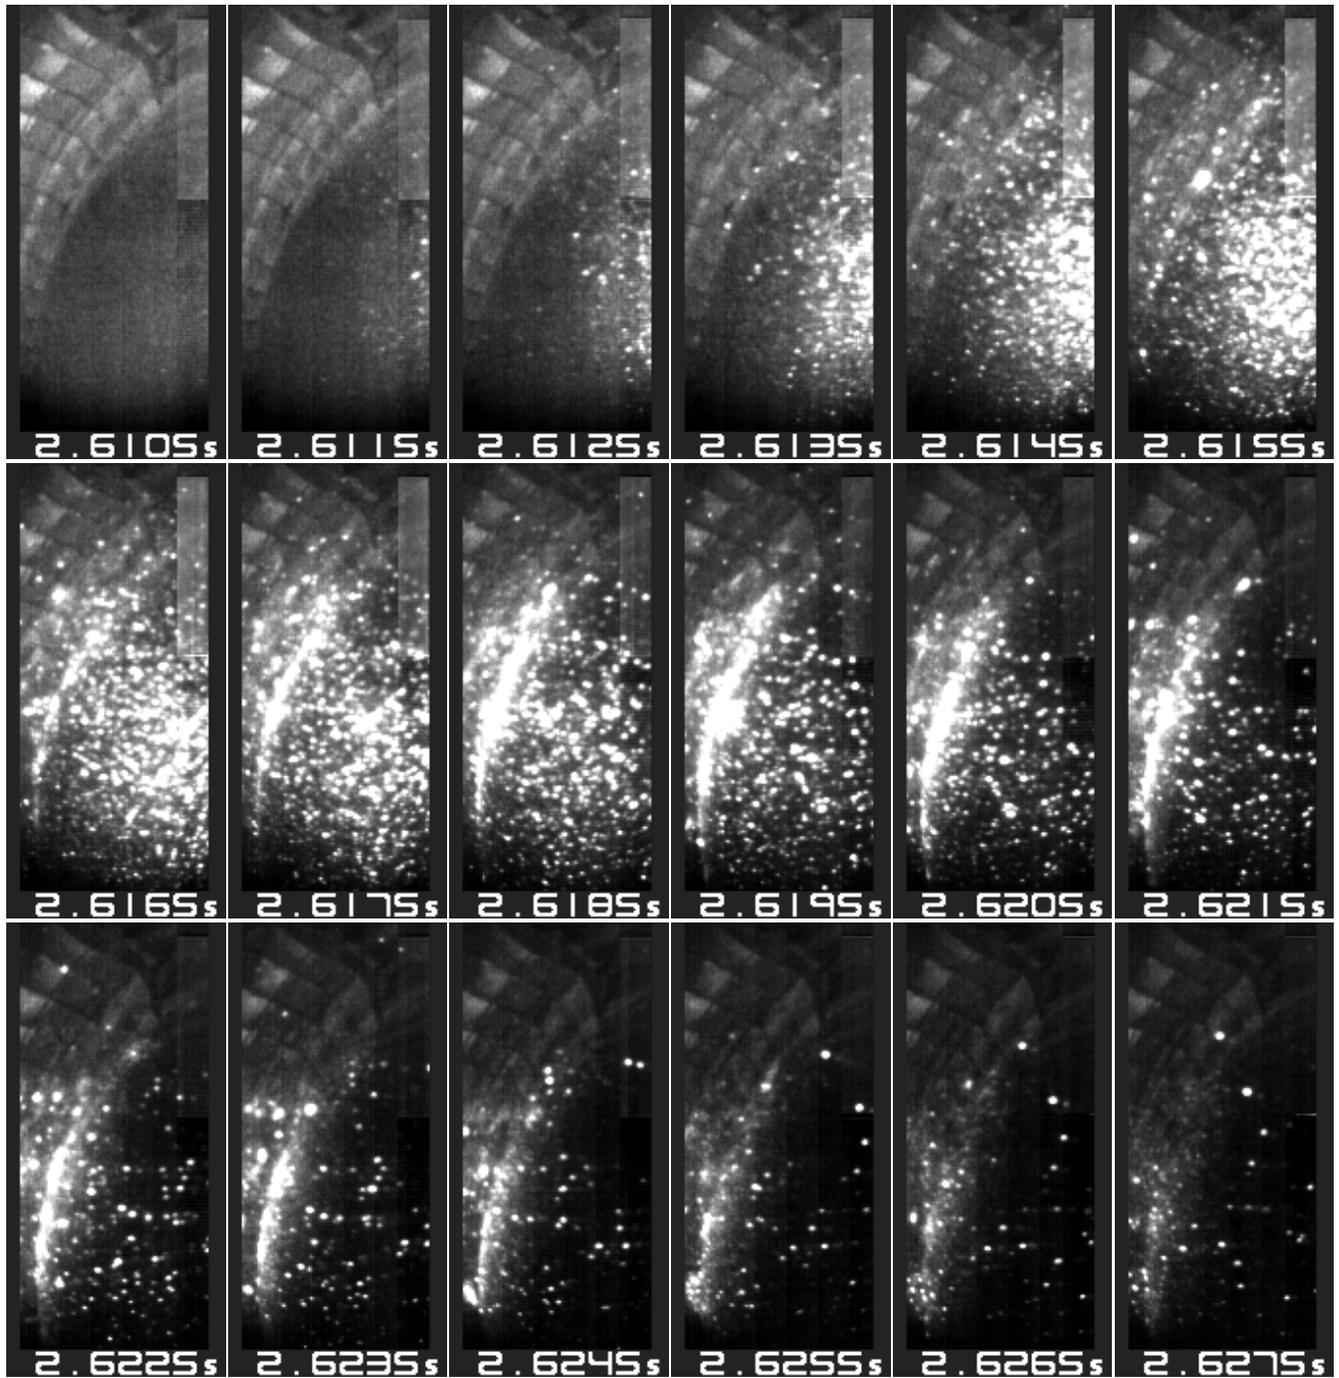
Fig. 1. Horizontal shower of debris “falls” over the inner bumper limiter of TFTR. The images were obtained with  $30 \mu\text{s}$  exposure in white visible light (i.e., no interference filter).

Tokamak plasma discharges occasionally end with a disruption: a sudden loss of equilibrium and confinement. Some of these disruptions are caused by MHD perturbations that stop rotating with the plasma column, lock on to the wall (i.e., field error), and grow in amplitude without saturation [5]. In Fig. 1 the effects of a disruption caused by a rotating  $m=4$   $n=1$  mode that locks to the vessel wall are shown (discharge 103681). This disruption takes place  $\sim 2.425$  s after discharge initiation. The images in this figure were obtained at a sampling rate of 2 kHz, although every other image (i.e., 1 ms spacing) is shown. As a reference, the tiles on the bumper limiter are nominally 10 cm $\times$ 10 cm in size.

In this example a  $\sim 0.6$  MA toroidal current remains after the disruption. This current is mostly carried by runaway electrons created by the strong electric fields present during the quench of the toroidal (ohmic) plasma current [5]. These high energy ( $\sim 20$  MeV) electrons collide into plasma facing components causing damage. In Fig. 1 the damage manifest itself by a (horizontal) shower of debris that “falls” over the bumper limiter above the device midplane. Although not as spectacular as the example shown here, flying debris is almost always seen after disruptions. The diameter of the hot-glowing flying particles is estimated to be up to 1 cm and their speed is of the order of 100 m/s. It is speculated that the debris seen in these images is part of the Faraday shield for the RF heating antenna (IBW) that was located approximately opposite to the section of bumper limiter shown and that was noticed missing a few weeks later.
